Hot Corrosion of Single-Crystal NiAl-X Alloys

James A. Nesbitt
Lewis Research Center, Cleveland, Ohio

National Aeronautics and
Space Administration

May 1998

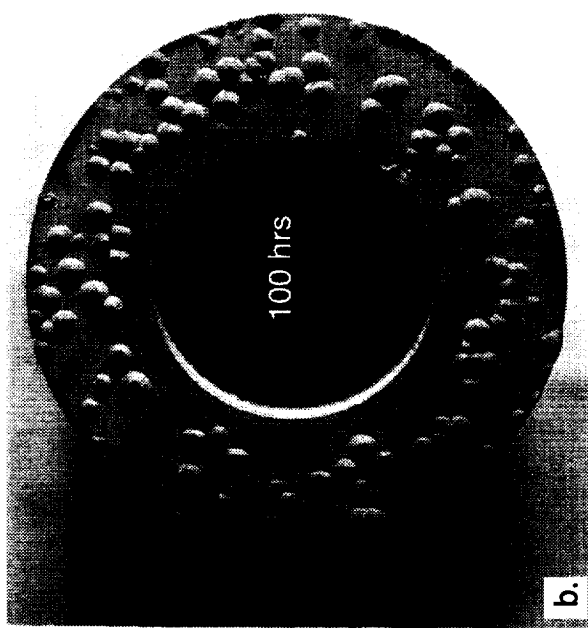
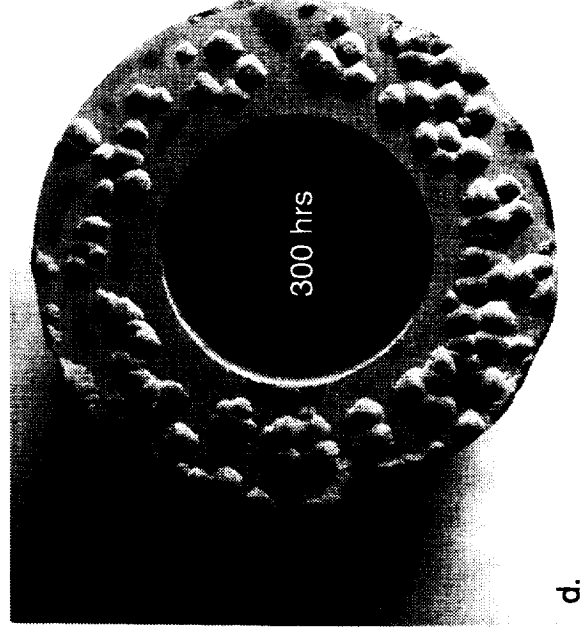
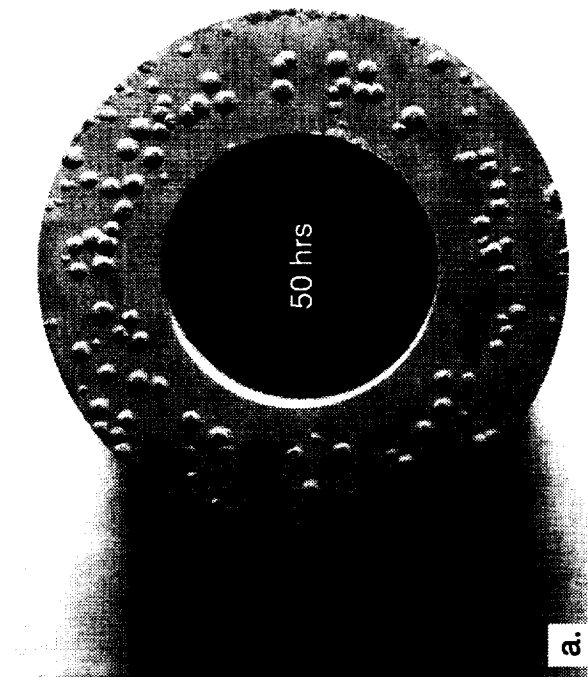
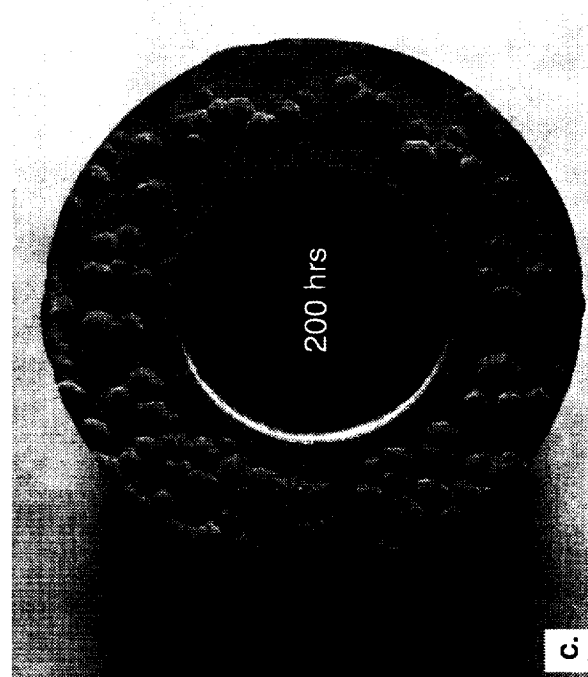
Fig. 81 Macro photographs of D219E after 50, 100, 200 and 300 hrs (Series III). Sample surface was polished through 600 SiC paper.

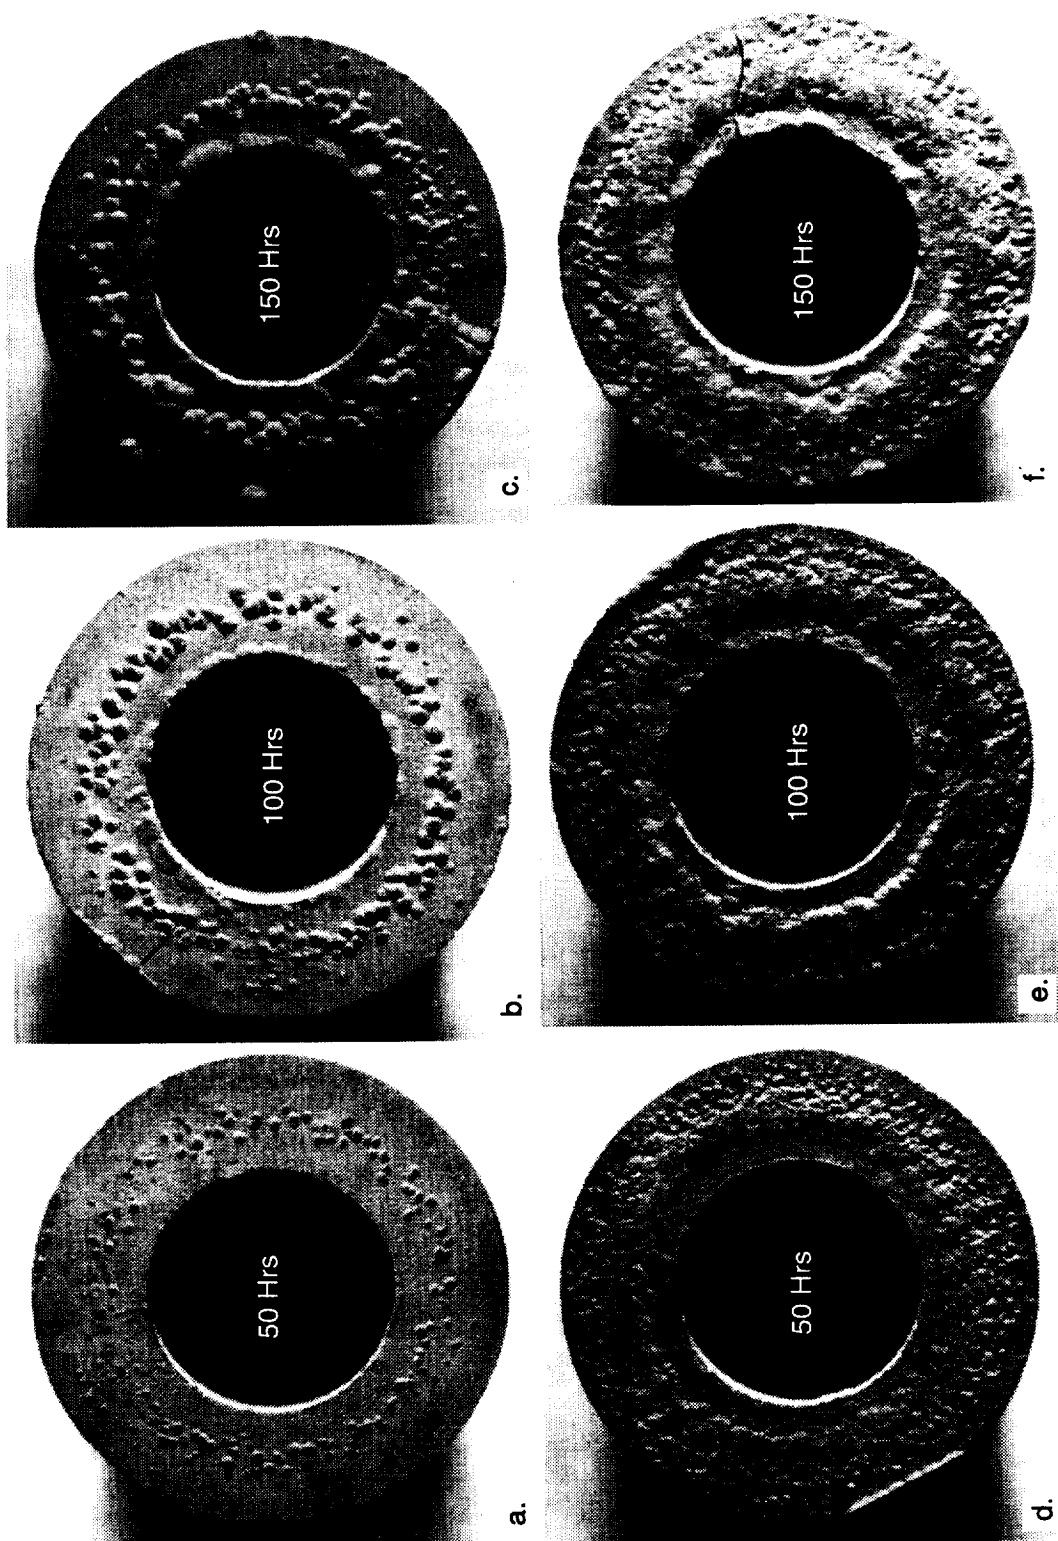
Fig. 82 Macrophotographs of the two ends of AFN20 after (a,d) 50, (b,e) 100 and (c,f) 150 hrs.

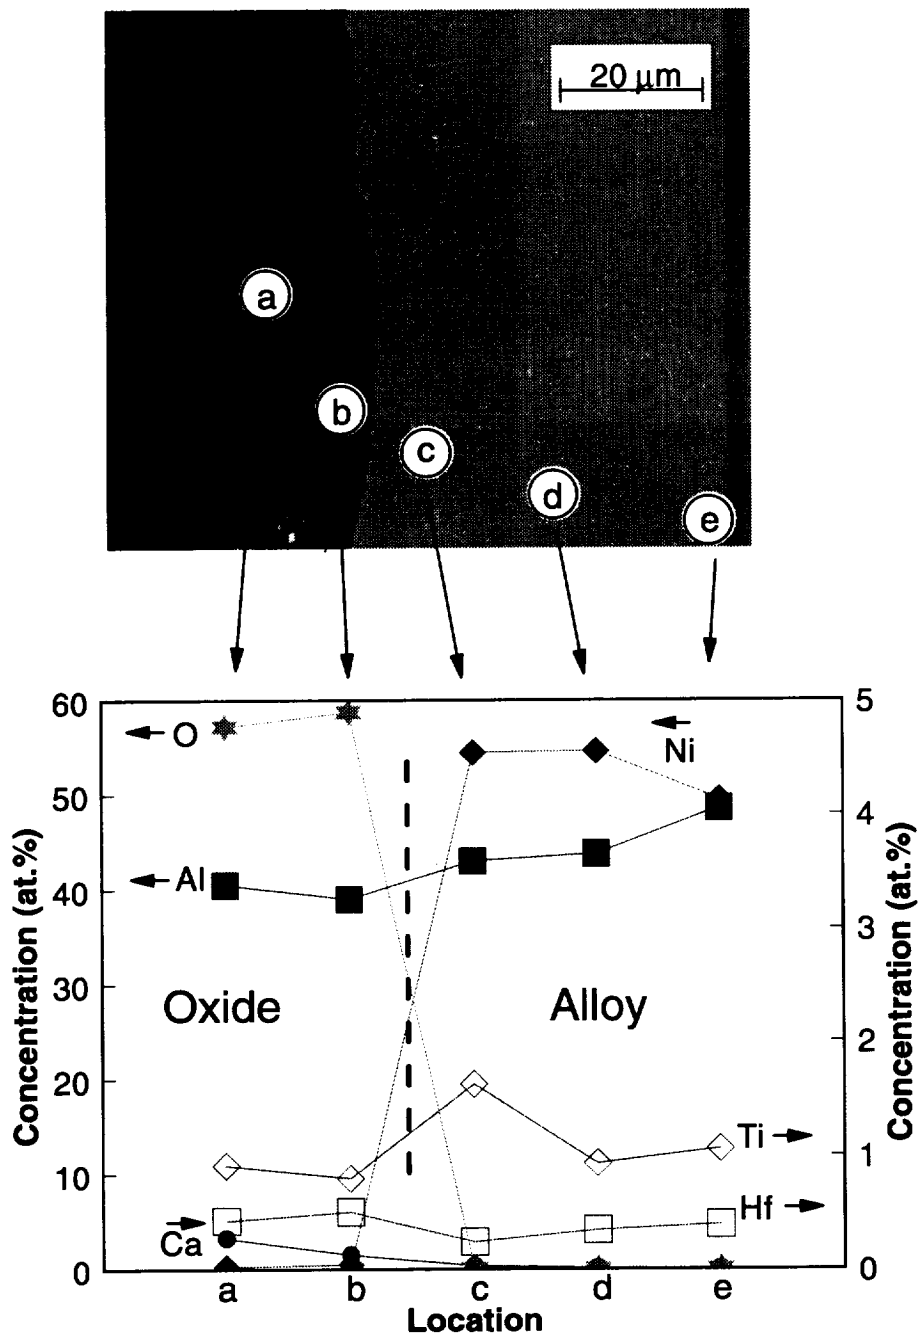
The discontinuous precipitation of γ' below the growing pits prior to rampant attack is likely due to the presence of Ti. The Ti appears to be rejected from small growing pits (Fig 88). However, as the inward growth of the pits increases, the Ti concentration in the β phase below the pits will also increase until the solubility of Ti in the β phase is exceeded resulting in the precipitation of the γ' ($\text{Ni}_3[\text{Al,Ti}]$) phase. Quantitative EMP measurements of the discontinuously precipitated γ' indicated a Ti content of almost 9% (Fig 99).

Fig. 88 Concentration profile below shallow pit shown in Fig. 87.

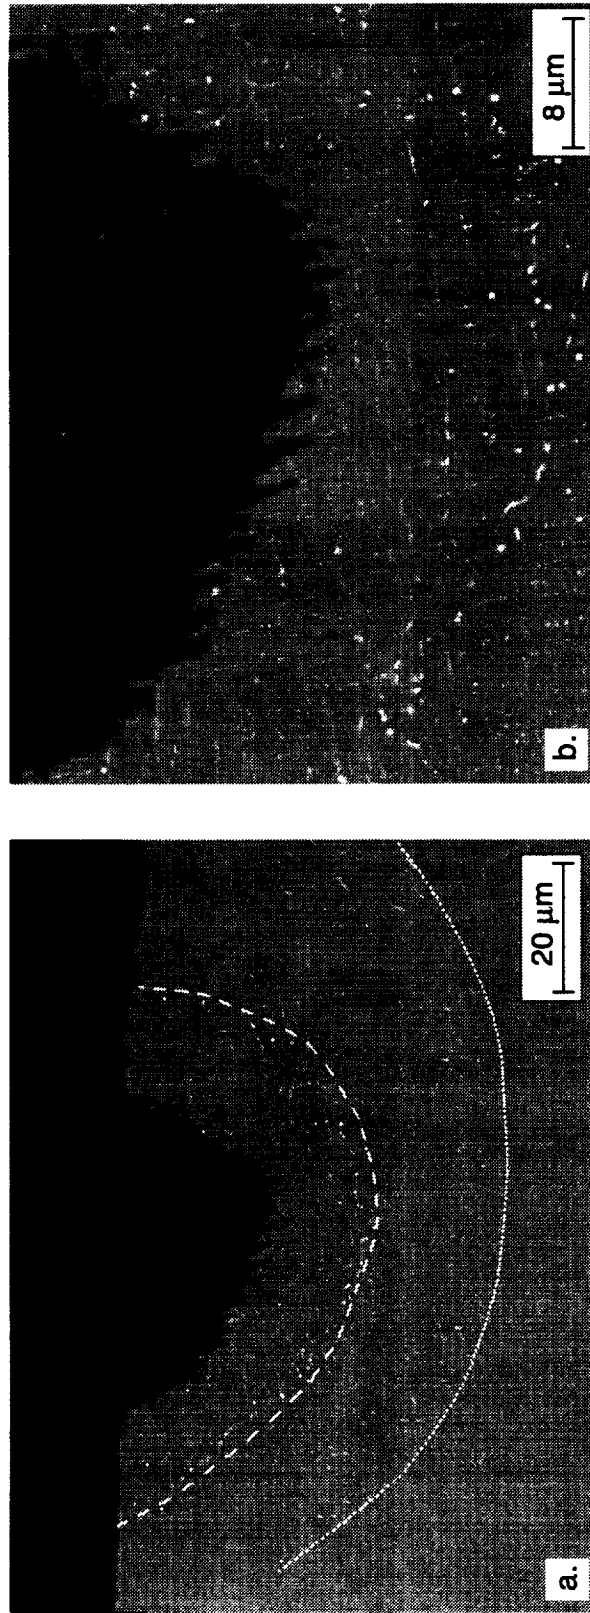
The small, bright precipitates below the growing pits (e.g., Fig 85b,c, Fig 90) are likely HfO_2 . Although the O solubility in NiAl would be extremely small, some O will diffuse into the alloy and internally oxidize the oxygen-active Hf. Since the Heusler phase precipitates ($\text{Ni}_2\text{Al}(\text{Hf},\text{Ti})$) are enriched in Hf, it seems likely that the internal oxidation of the Hf would cause dissolution of the Heusler phase in the internally oxidized region. This dissolution has been observed in some cases, but not others. The different morphologies of the HfO_2 precipitates could be related to the original Heusler particle orientations.

Fig. 90 Deeper pit in D218 showing preferential growth along crystallographic planes (a) dashed lines indicate diffusion affected bands below pit (b) higher magnification showing precipitates aligned with previous Heusler precipitates.

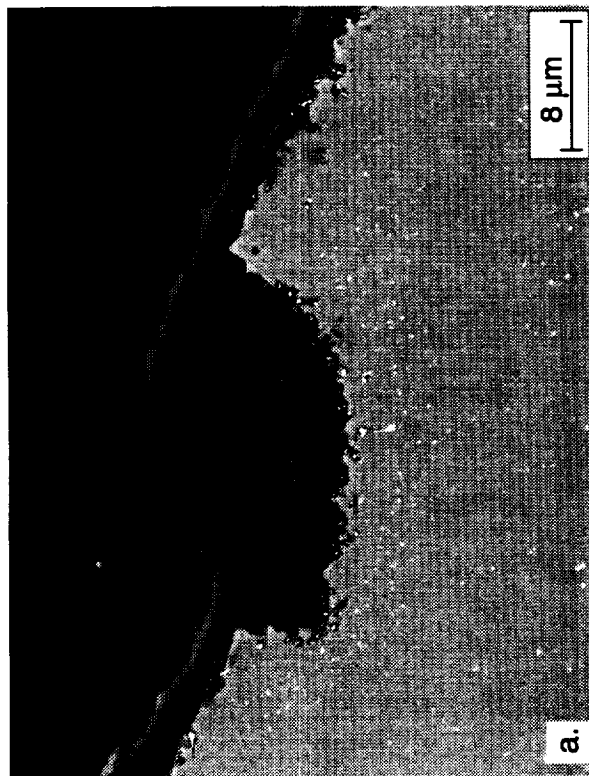
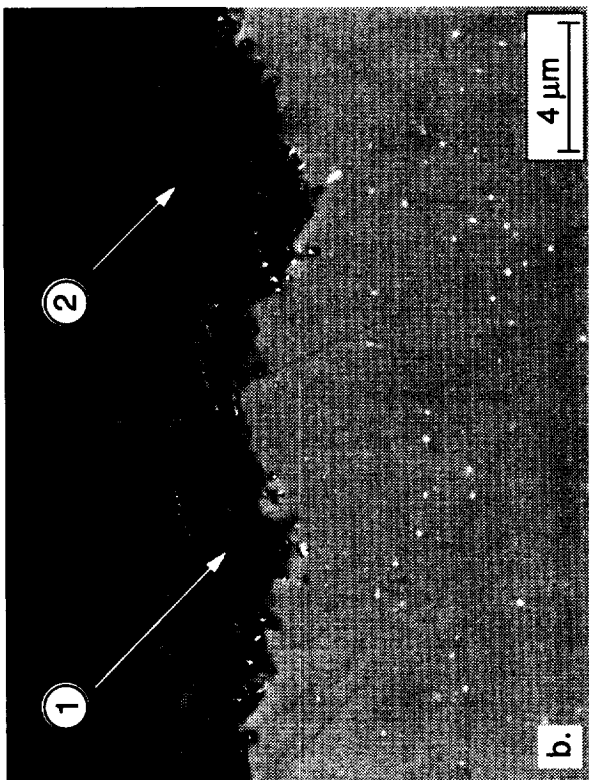
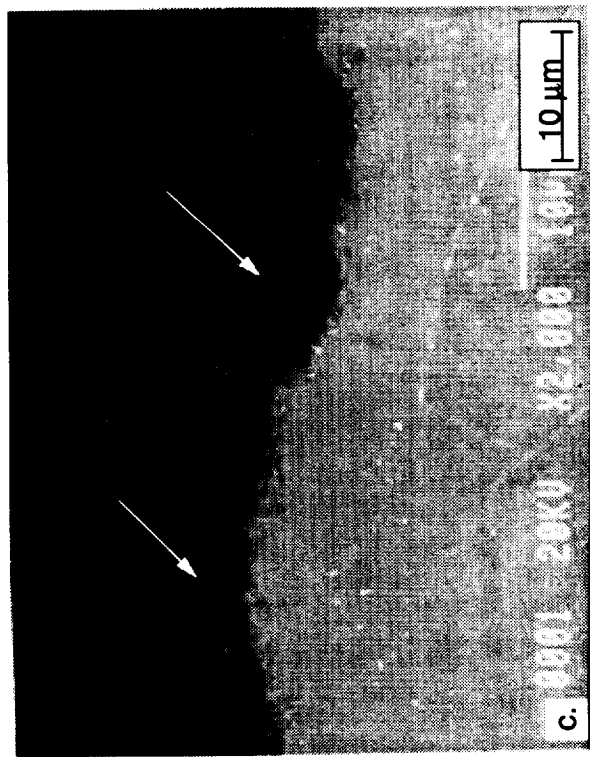
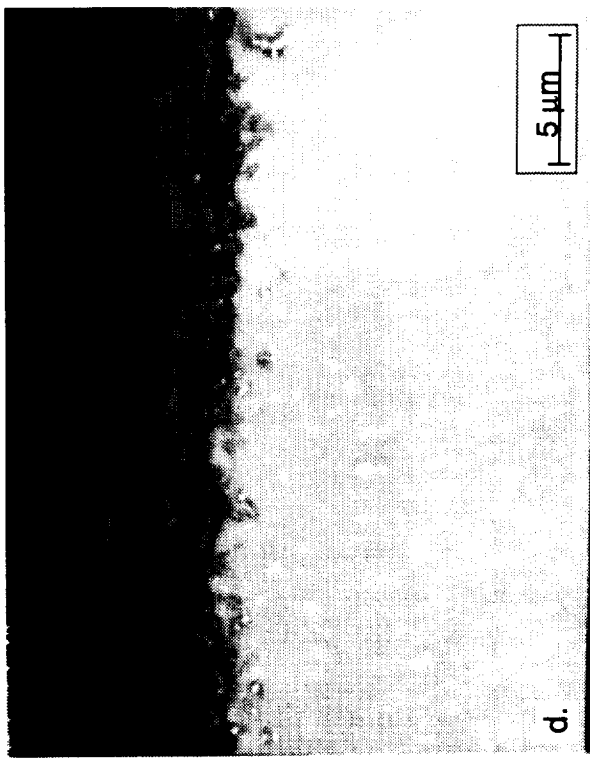
Fig. 91 Possible initiation sites in (a) AFN19, (b) D219 and (c,d) AFN20.

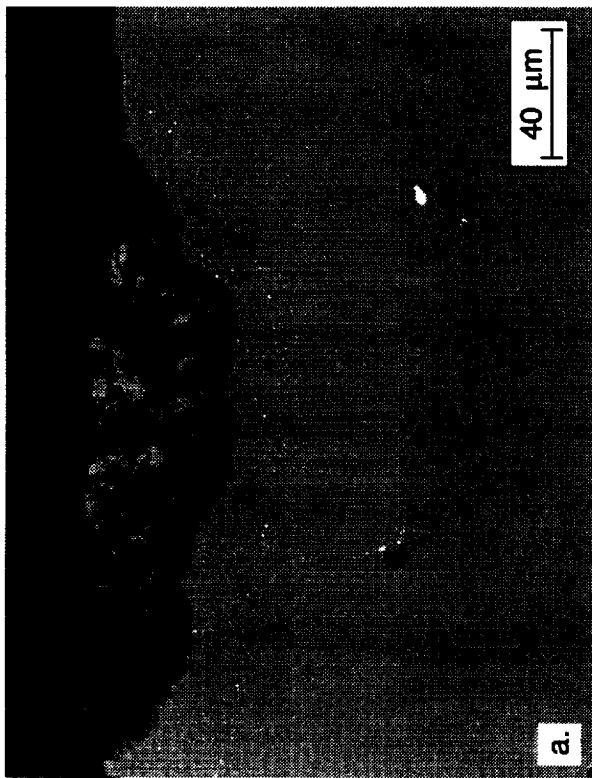
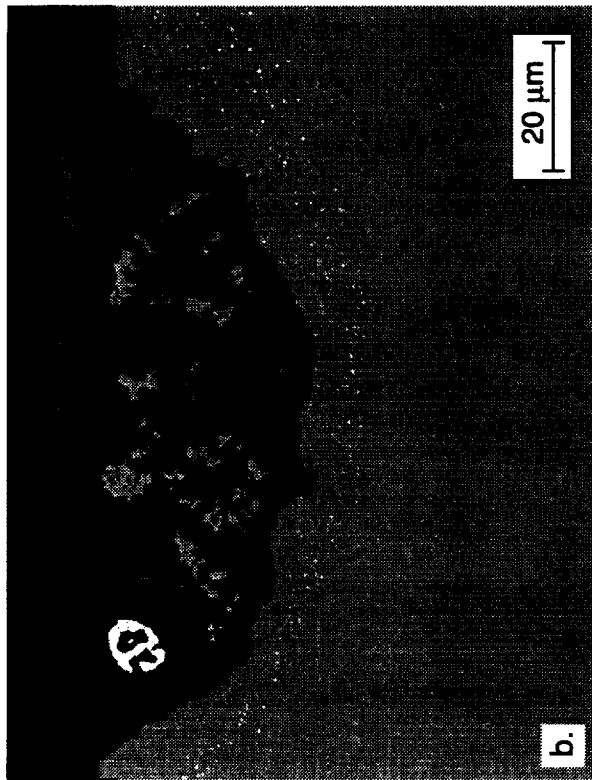
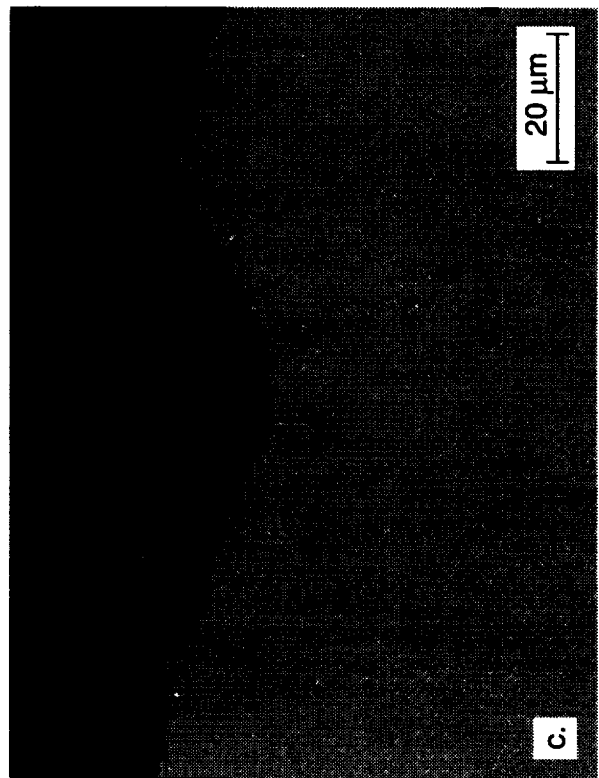
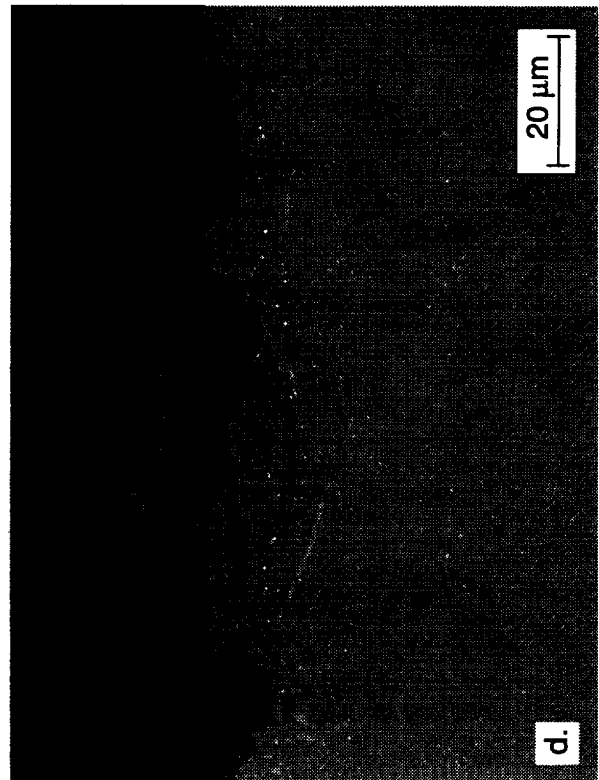
Fig. 92 Intermediate attack (a,b) in D218 (c,d) in AFN19.

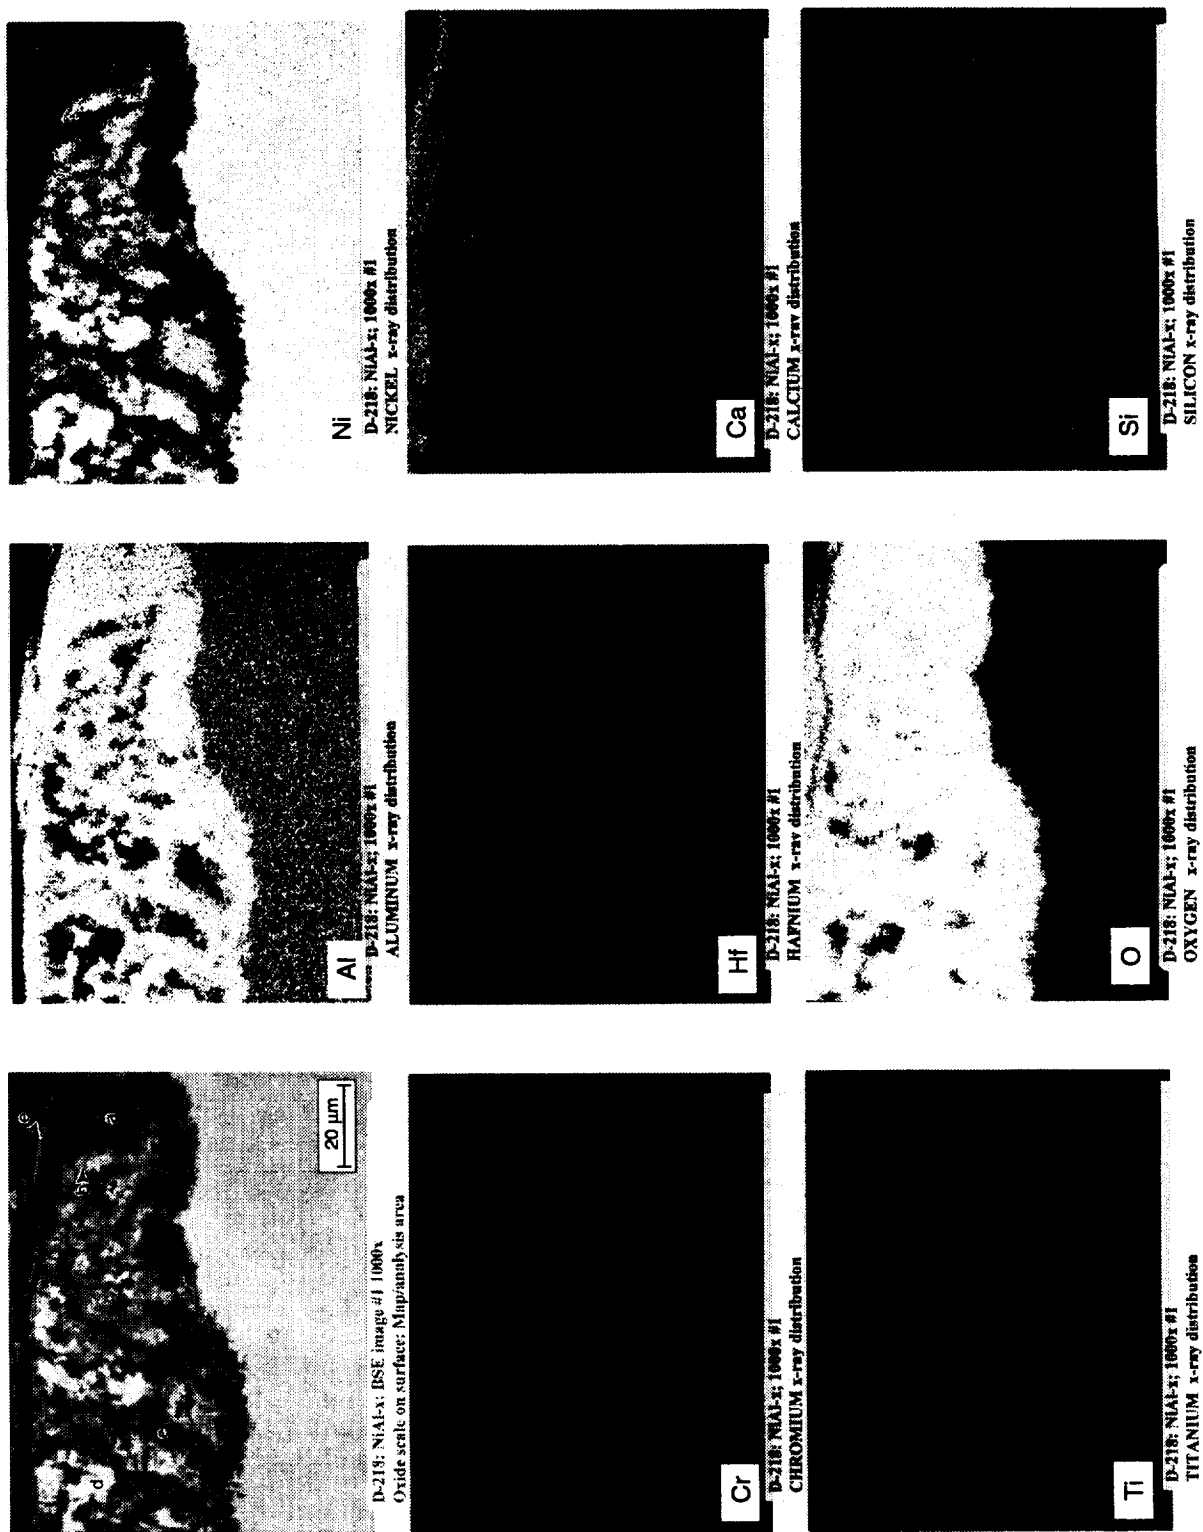
Fig. 93 X-ray maps of intermediate attack in Fig. 92a shown in Fig. 92a (Probe image is inverted from that in Fig. 92a)

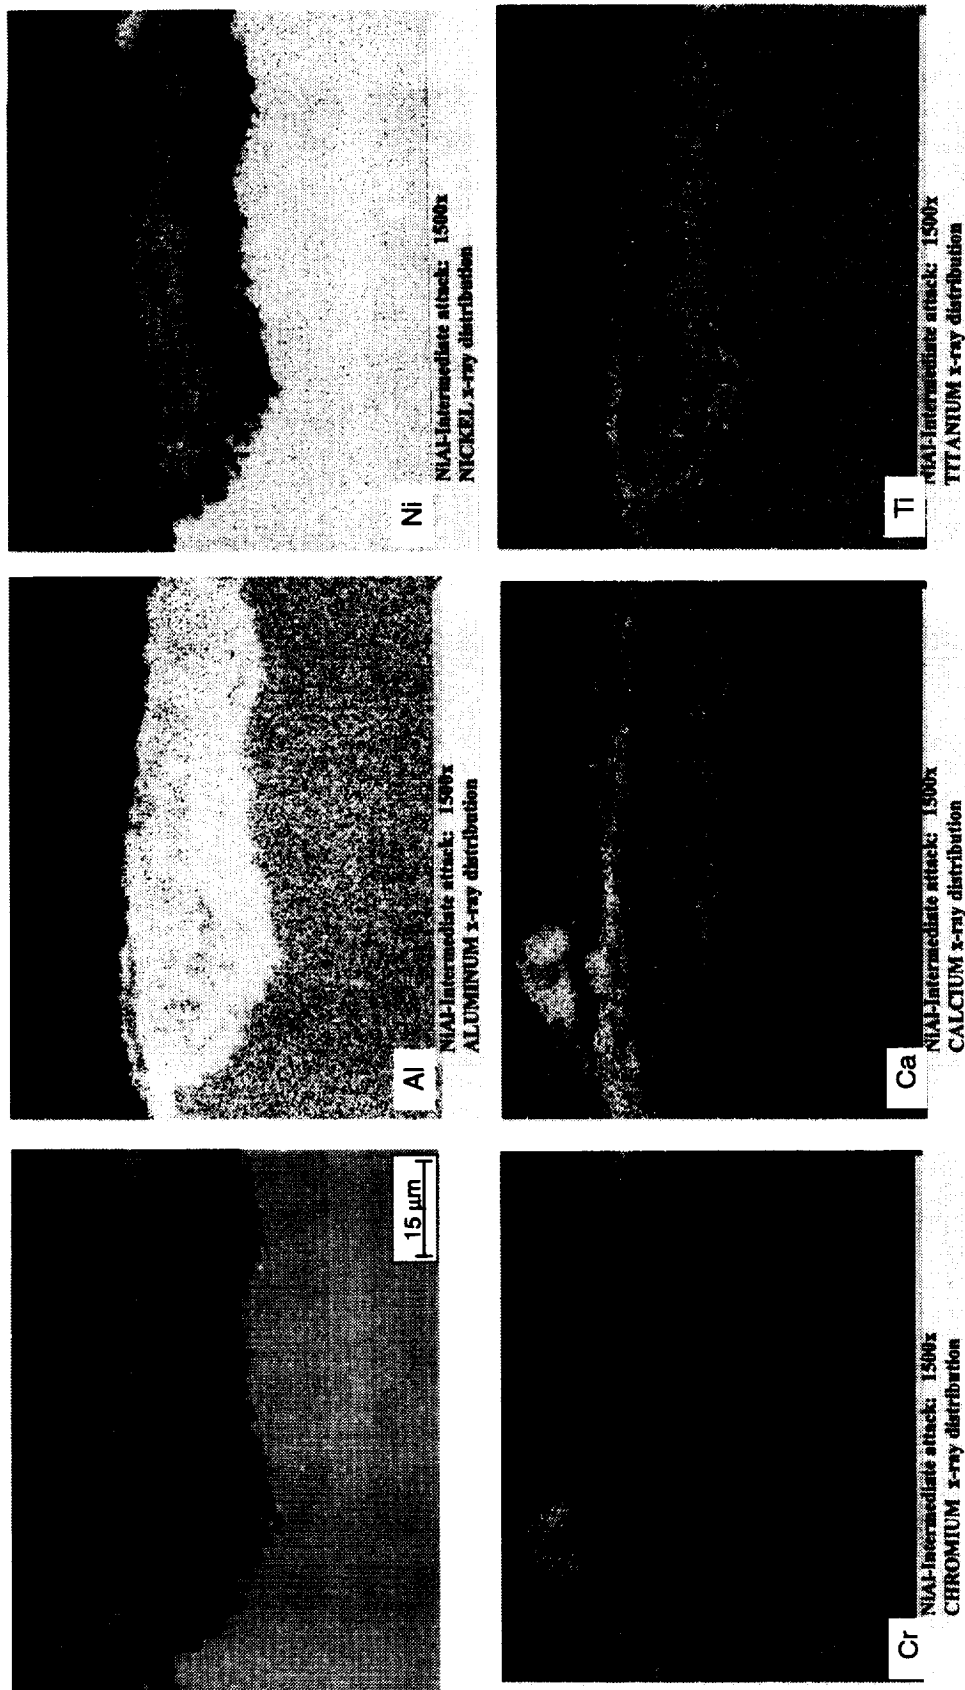
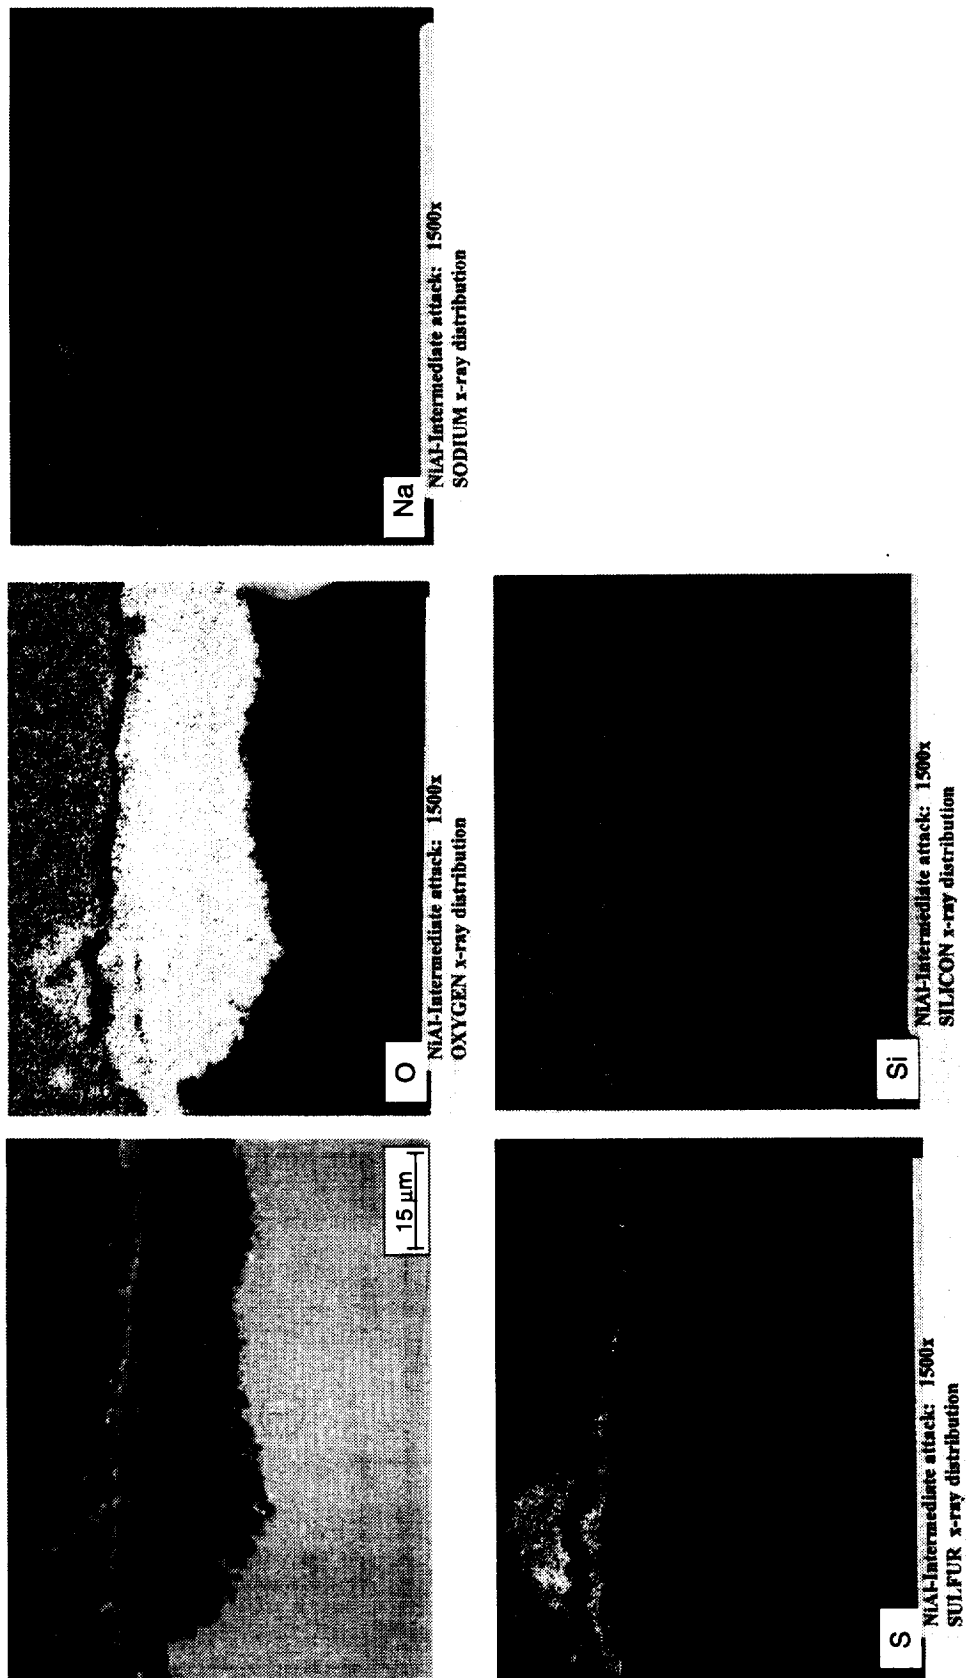
Fig. 94 X-ray map of pit in transition between initiation and intermediate attack on AFN19 after 300 hrs.

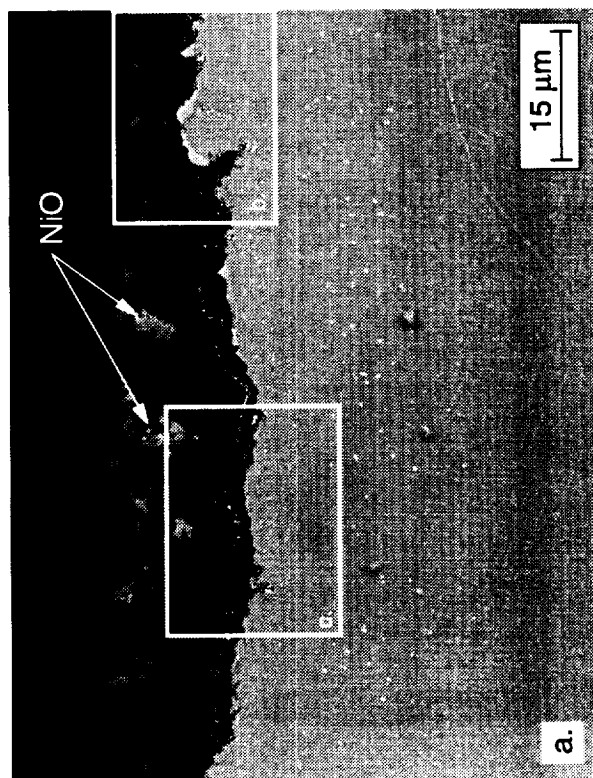
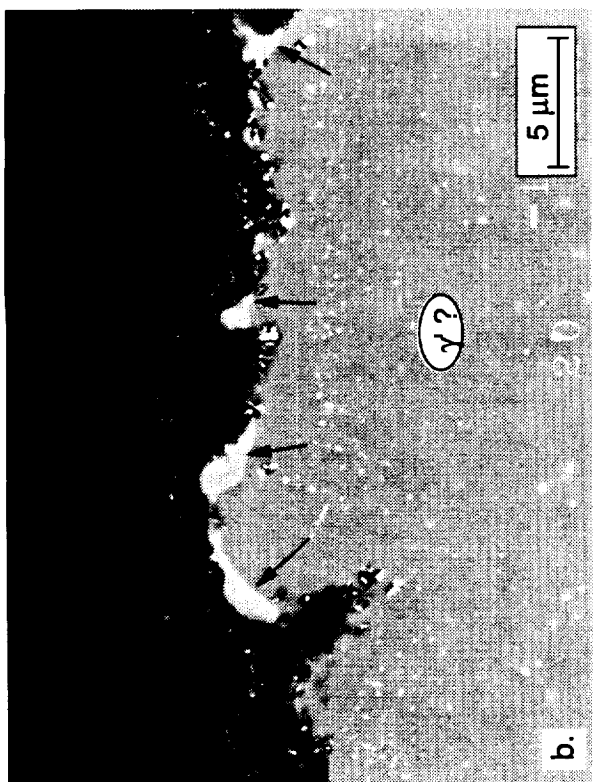
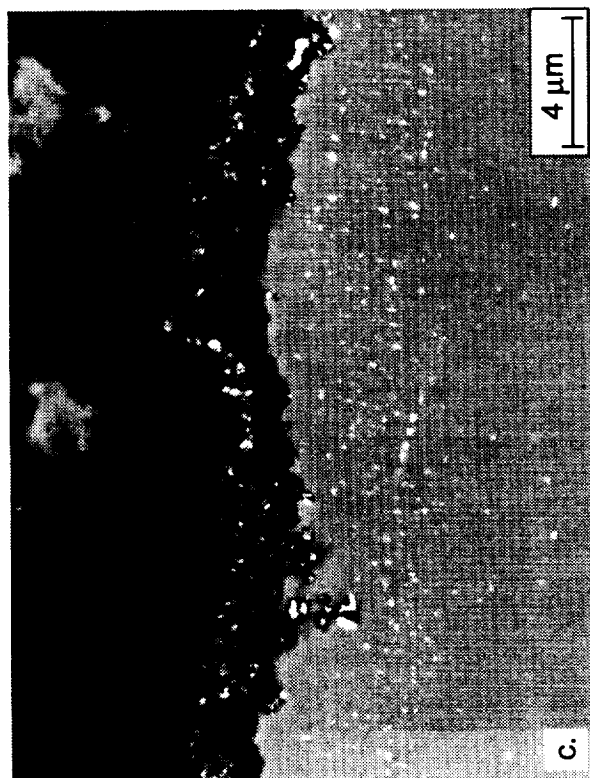
Fig. 96 Intermediate attack in D219. Arrows in (b) indicate likely γ formation.

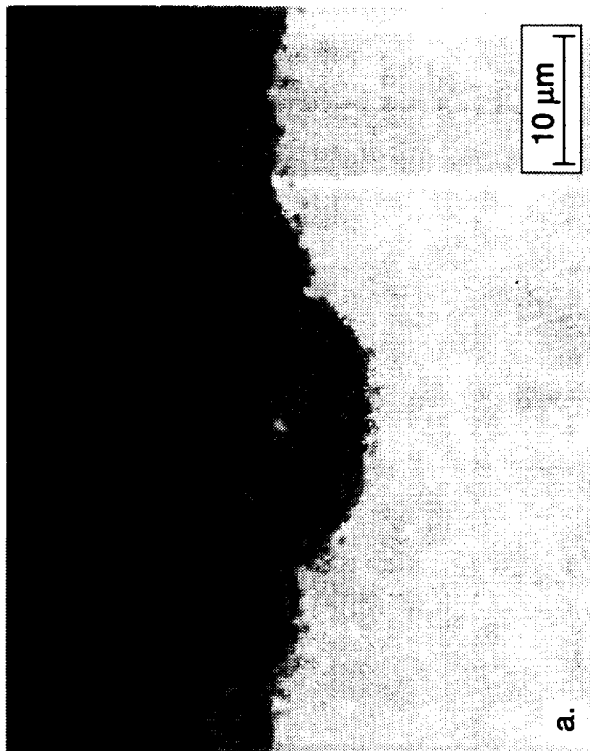
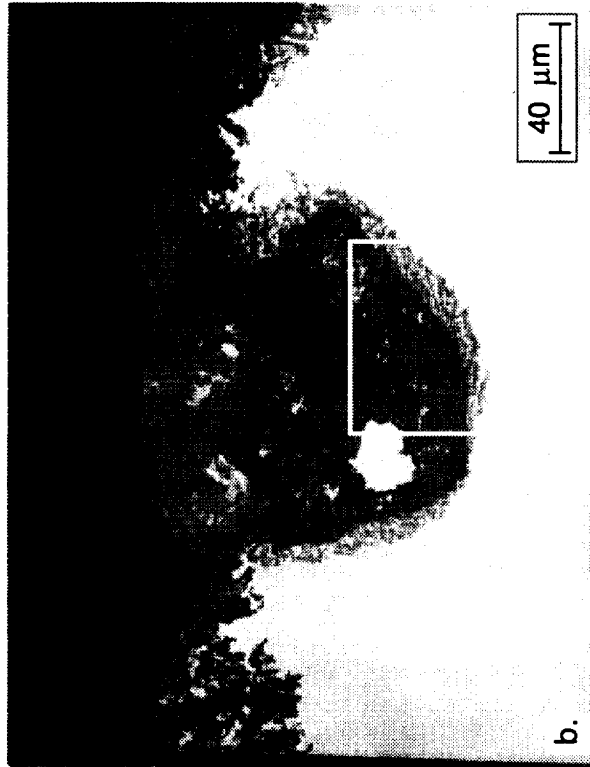
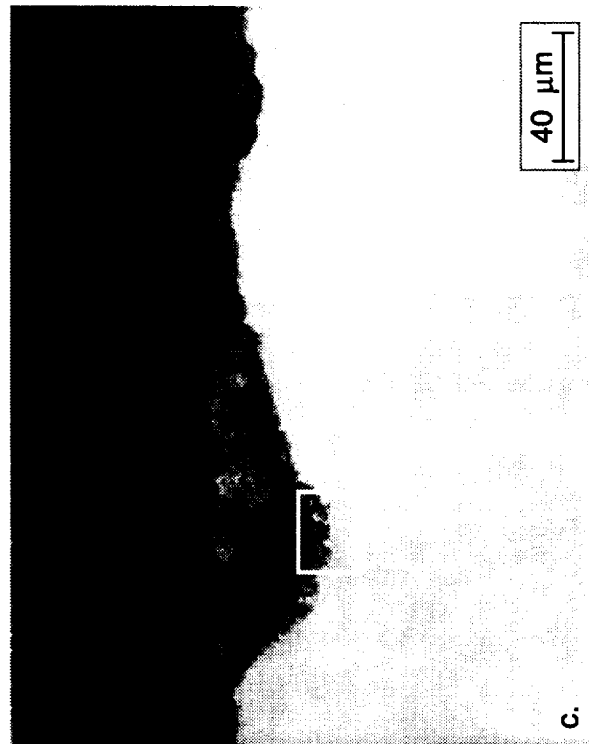
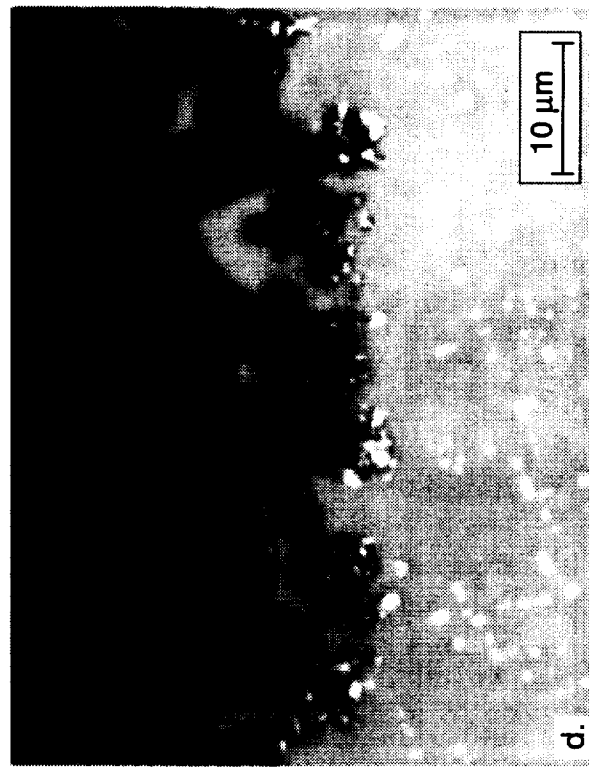
Regions of intermediate attack in AFN20 are shown in Fig 97. The magnified view of the bottom of a pit (Fig 97d) shows a second oxide with a lighter shade of gray mixed with the darker Al_2O_3 scale. EDS analysis indicates that this lighter oxide contains significant Ti and is likely either TiO_2 or a mixture of TiO_2 and Al_2O_3 , possibly containing some HfO_2 . This fine, light and dark structure within the Al_2O_3 was common. The x-ray maps in Fig 98 of the corrosion mound shown in Fig 97a clearly show that Ca is distributed throughout the mound. Cr is again enriched on the surface and Hf is enriched near the base of the mound with some HfO_2 fingers, slightly discernible, penetrating into the alloy. The Ni map indicates a small region of NiO in the center of the mound surrounded by a Ni- and Al-rich oxide, presumably NiAl_2O_4 . Ti is present with the Al_2O_3 throughout the mound and appears slightly enriched in the alloy below the mound. Quantitative probe measurements were made at the points indicated as a-e. All points show primarily Al_2O_3 with varying amounts of Ni, Ti and Ca, and reflect the enrichments and depletions shown in the maps.

Fig. 97 Intermediate attack in AFN20. Image (d) is a higher magnification of the box shown in (c).

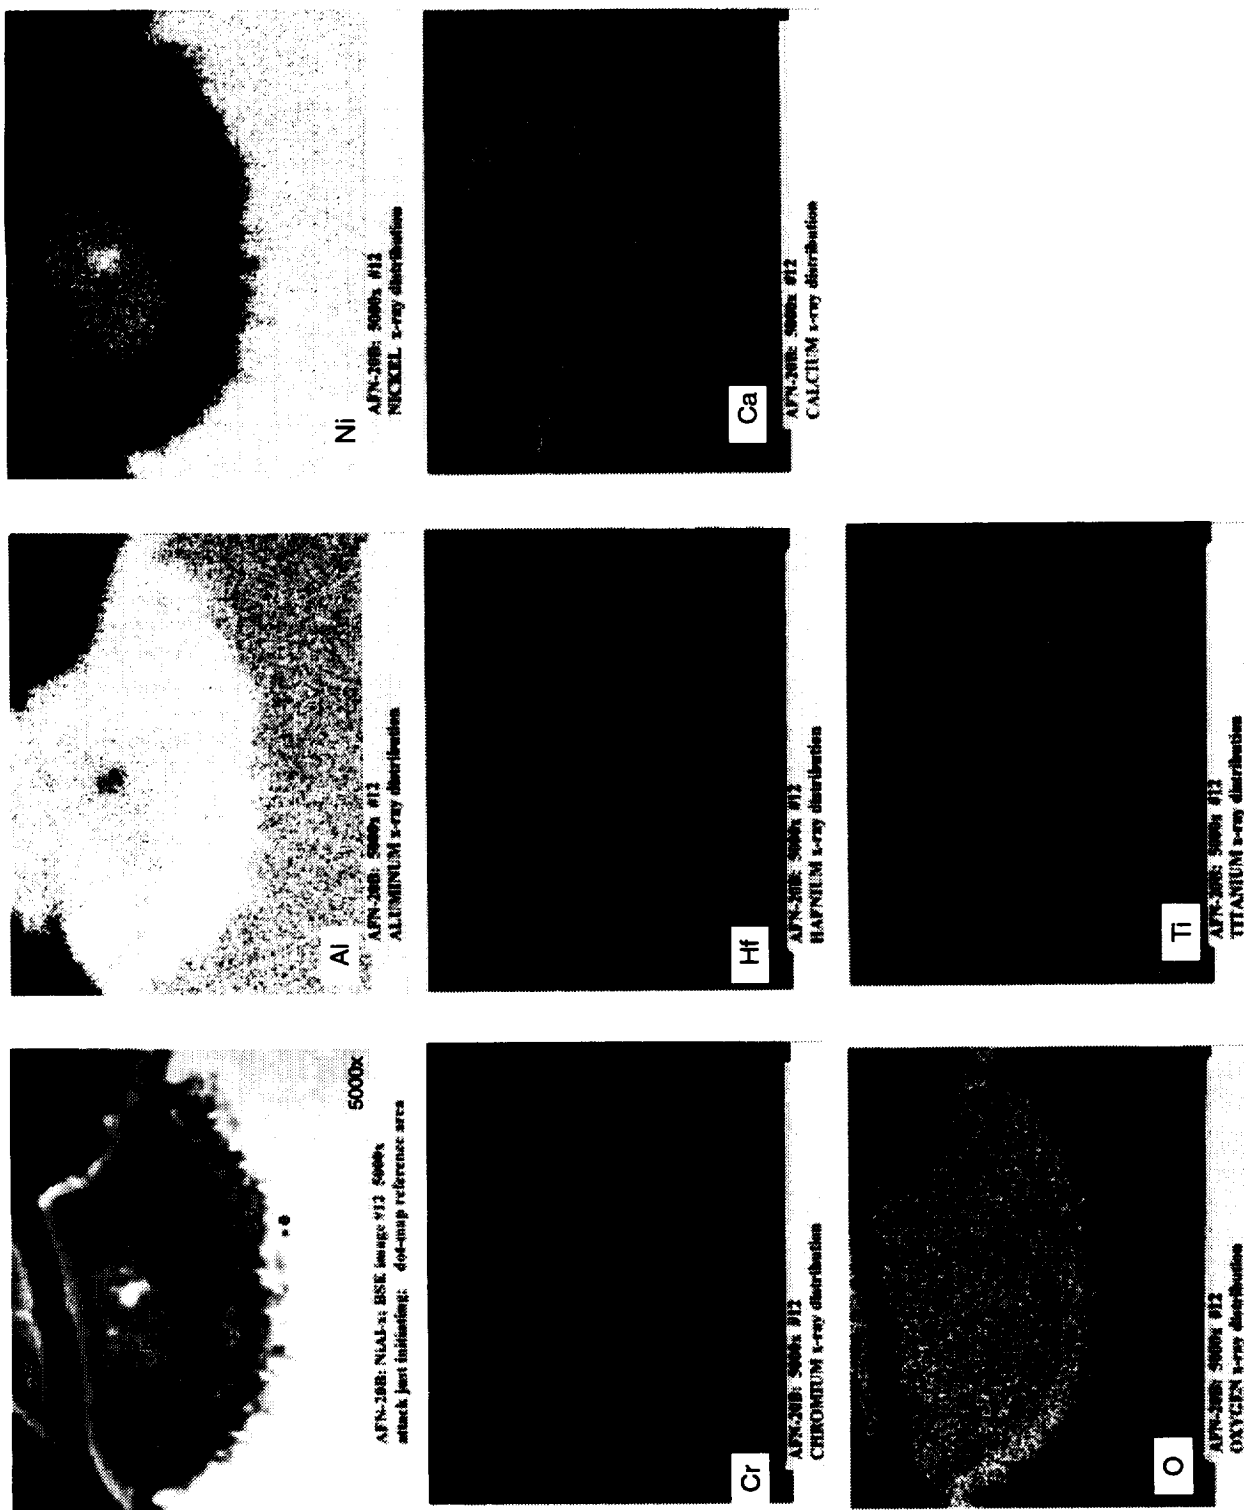
Fig. 98 X-ray maps of intermediate attack in AFN20 shown in Fig. 95d.

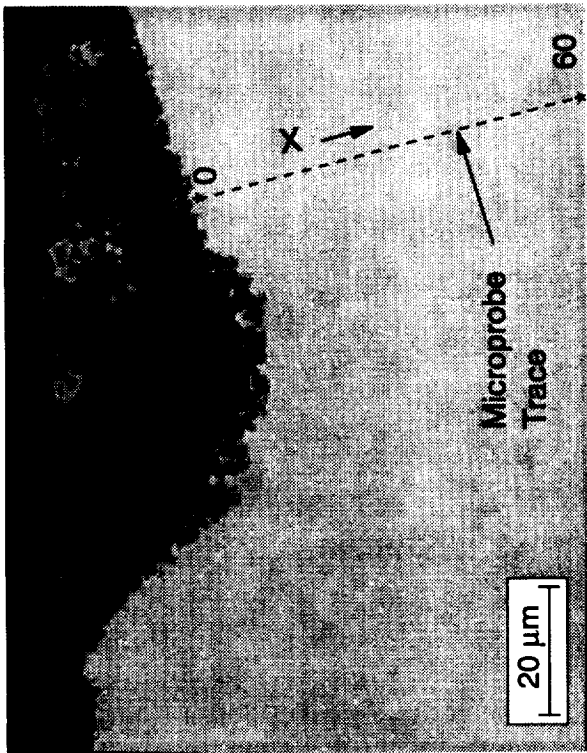
Fig. 100 Concentration profile in AFN20 below region of intermediate attack shown in Fig. 97c.

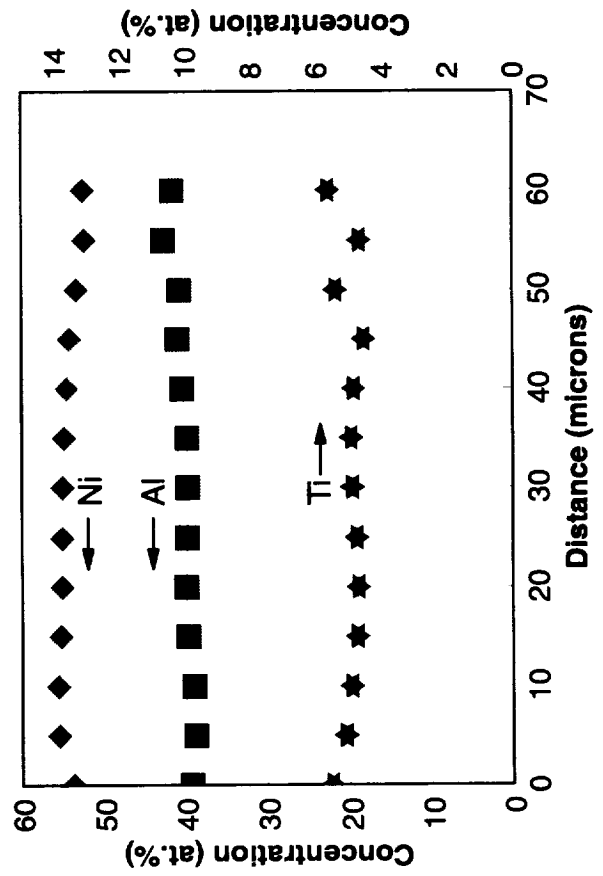
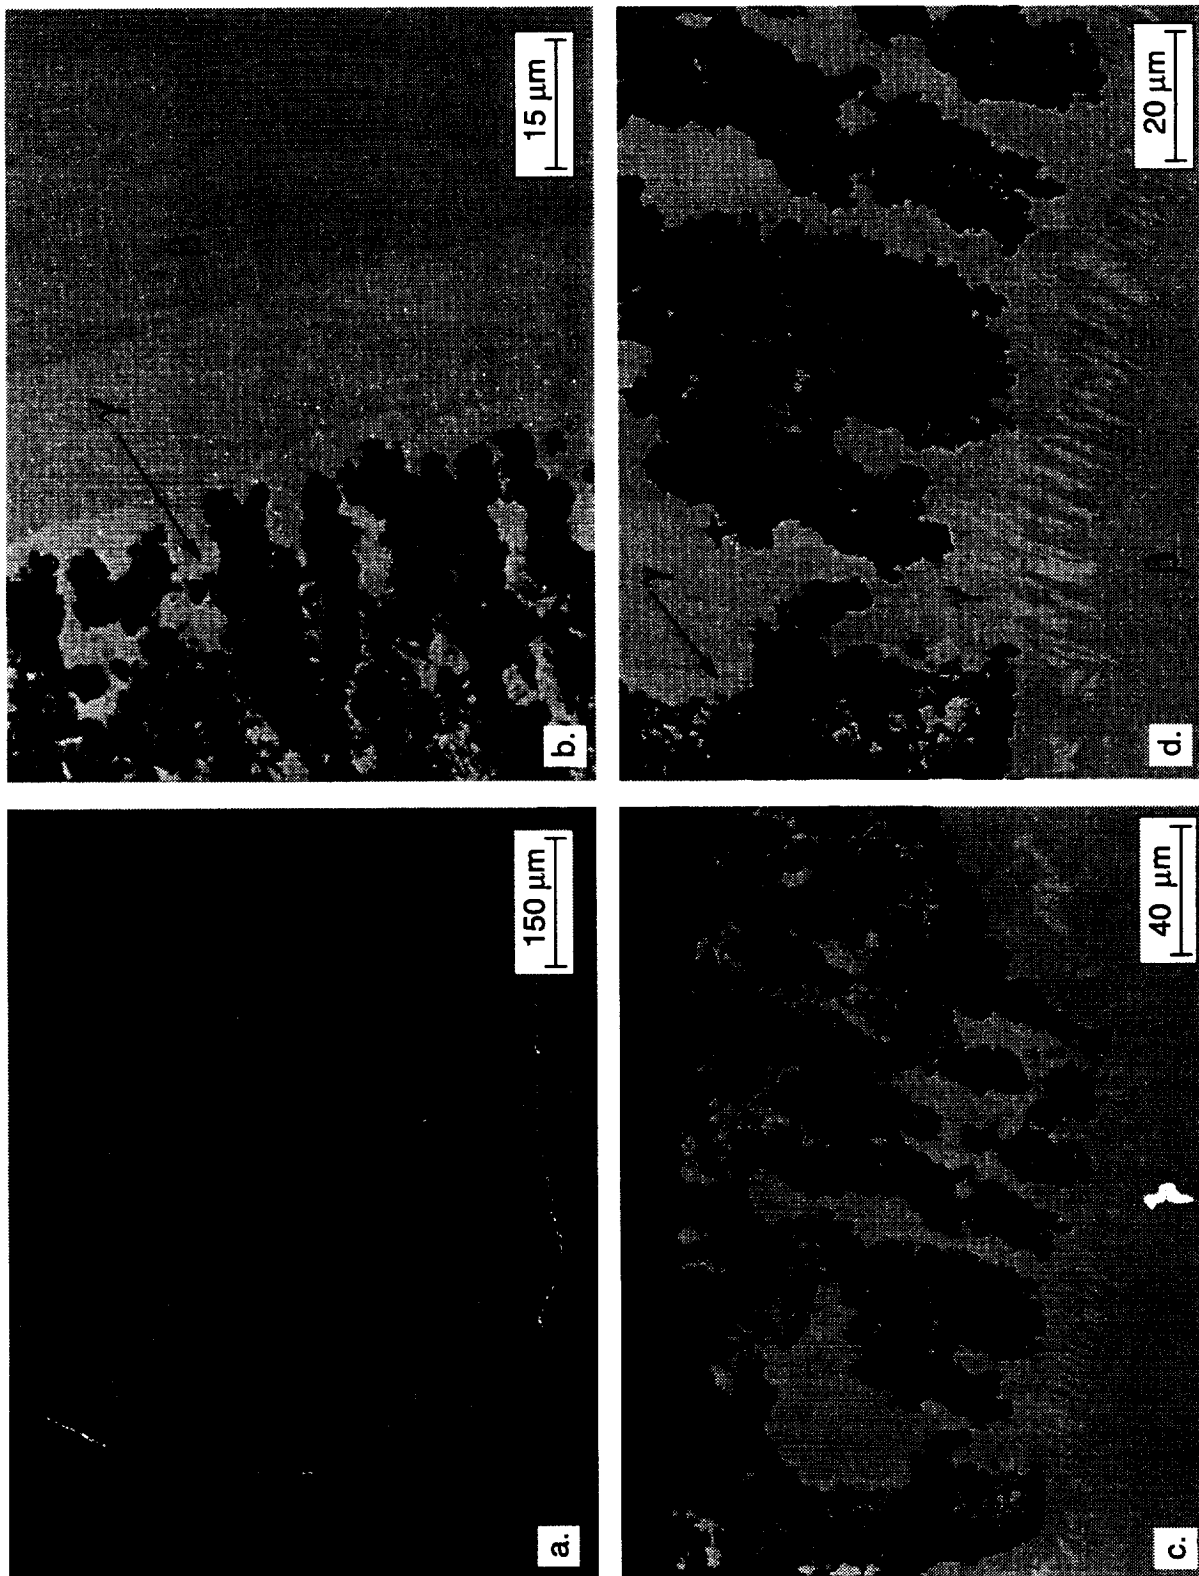
Rampant attack exhibited a fairly characteristic microstructure on each of the alloys. This attack morphology always consisted of rapid inward penetration of Al_2O_3 stringers trapping large amounts of Ni within the scale. The Ni was typically depleted of Al and had transformed to either γ' or γ . Regions of rampant attack on D218 and AFN19 are shown in Fig 101. The magnified views show that the depletion of Al has resulted in the formation of γ' (Fig 101b,d). Some γ was also observed near the oxide/ γ' interface (Fig 101d) or well within the attacked region. Often the Ni islands had been oxidized to NiO in the outer portion (nearer the oxide/gas interface) of the attacked region. The γ'/β interface shows a feathery γ' phase penetrating into the β in Fig 101d. The light and dark oxide

Fig. 101 Regions of rampant attack on (a,b) D218 and (c,d) AFN19. Images (b) and (d) are higher magnifications of (a) and (c).
